TO WHOMSOEVER IT MAY CONCERN

REFRIGERANT HALIDE FLAME TESTING FOR CONTAMINATION

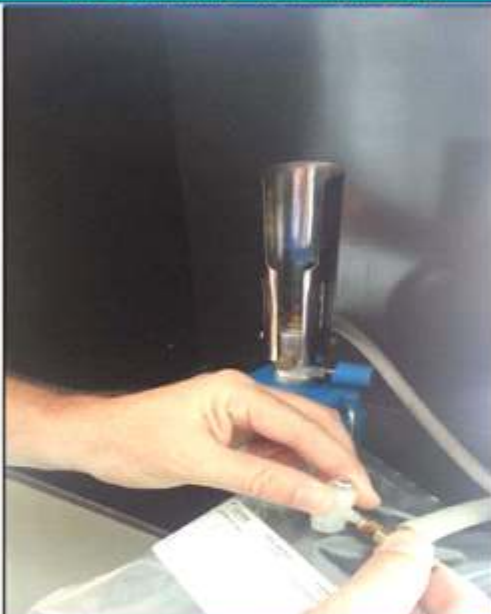
| Lite Blue Flame - R-134a (no CFC) | Green Flame - Contaminated CFC | Vivid Blue Flame - Contaminated R-40 |
| <p>Flame is almost invisible but has a lite blue central core where the gas flame reacts with the copper reaction plate. As R-134a passes through the testing hose there will be a slight waving of the flame as it burns the refrigerant excess flow will cause roange flame (lack of oxygen) and eventually flame extenguished.</p> | <p>Flame can easily be seen to change to a green tinge as the Chlorine in the refrigerant (CFC) reacts with the copper reaction plate. Most likely cause is a mixture of R-22 and/or R-142b which is cheaper than R-134a.</p> | <p>Flame may start as green colour, but as more flow of refrigerant passes through, then it dramatically turns to an electric blue colour and onwards to vivid blue/purple. This is most likely R-40 mixed with other CFC refrigerants and R-134a. This is what caused the explosions when unit was powered up and reacted with moisture at 473°C.</p> |
| SAFE TO BE USED | DO NOT USE | DO NOT USE - STORE SAFELY FOR DESTRUCTION |

To ensure Safety of the reefer container units and people's lives, Halide Flame Testing will be introduced as mandatory safety norm to rule out contamination prior to refilling of the container with refrigerant. It is requested your vendor carries a Halide Torch during refilling of reefer containers with refrigerant so they effectively carry out the flame test in presence of our reefer technical team.
